Whistler Village Access Audit

*A Review Of The Whistler Town Site
For Barriers To People With Disabilities*

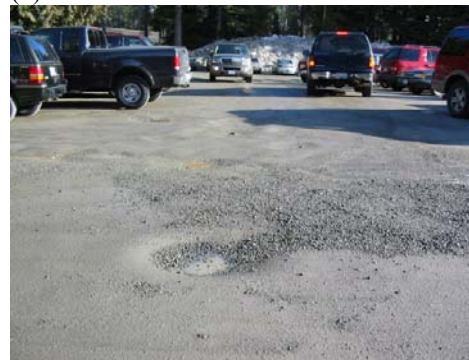
(2)

Lots 1 – 8 are all gravel lots which winter weather has scarred and worn, leaving deep potholes and uneven surfaces (2)(3). These areas present a significant falling hazard for people using walking aids as well as for people with mobility impairments and would be difficult for most wheelchair users to navigate. This is not appropriate parking for most older adults, seniors and other people with mobility impairments.

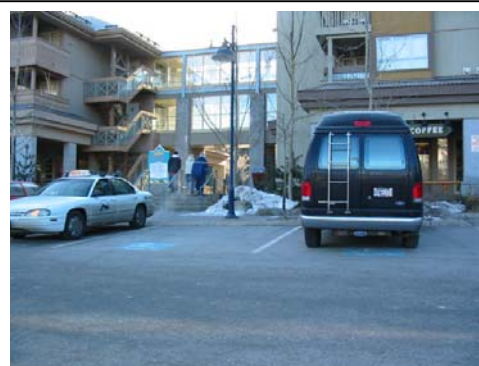
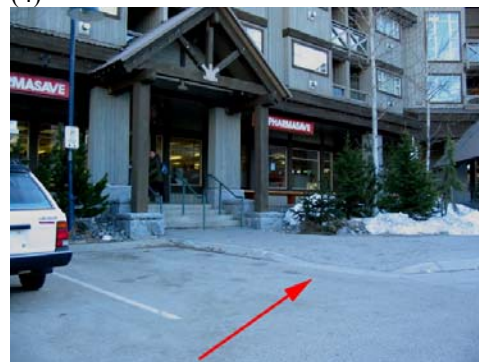
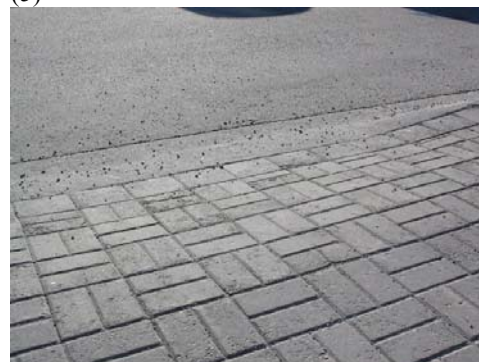
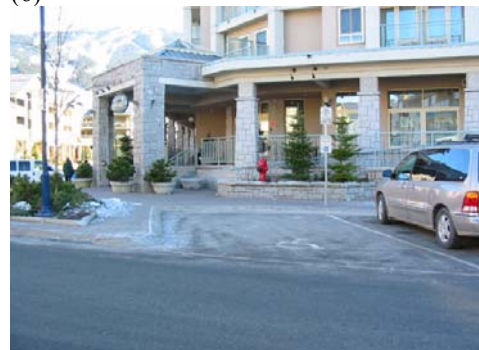
There are two designated spaces here, one large enough for a lift equipped van. These are located in a pay parking area where the dispenser is inaccessible to wheelchair users and other people with mobility impairments. There is no marked crossing to safely route users out of the parking area and across the busy adjacent roadway.

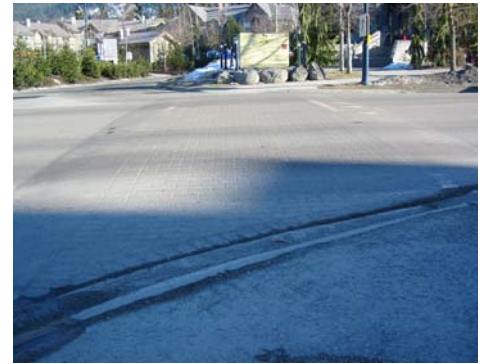
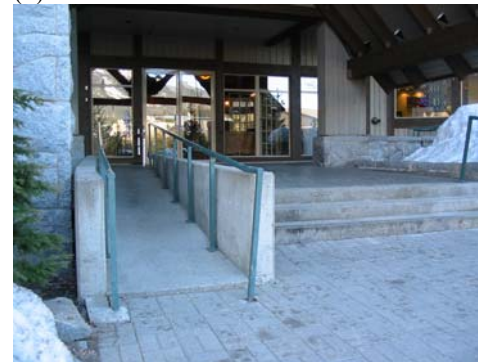
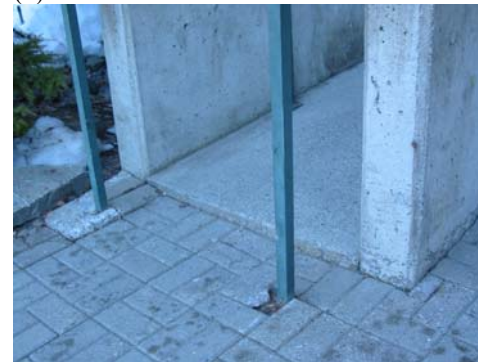
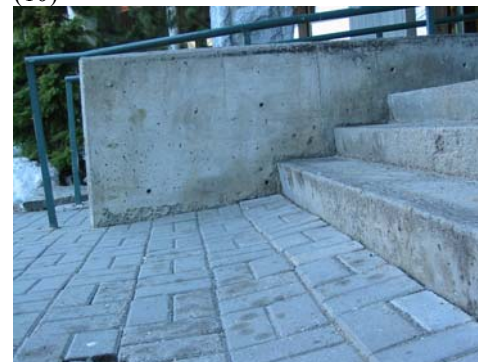
The access ramp from the parking lot to the Marketplace Lodge and adjacent shopping is a concrete ramp built to the maximum slope allowable. It has two contrasting handrails which make it easier to use for many people. However, the settling of the brick pavers has created a significant lip at the base of the ramp (9)(10). In addition to being a tripping hazard, this 2 -3 inch edge makes going up the ramp unnecessarily difficult for wheelchair users. For wheelchair users coming down, it creates a highly unstable transfer from ramp to sidewalk. The handrail supports at the base of the ramp are poorly located and are an unnecessary obstacle.

The stairs adjacent to this ramp offer three significant problems for users. First, these steps are equipped with only one handrail. People requiring a handrail on the opposite side would be at risk on these steps. Second, there is no tactile warning at the top of the stairs or high contrast nosings on each step as required by the current BCBC. Third, the settling of the pavers means that the base of the steps slopes away from the stairs, rather than provide a flat landing surface (11). This creates a high falling hazard for people using walking aids, visual impairments and people wearing ski boots.

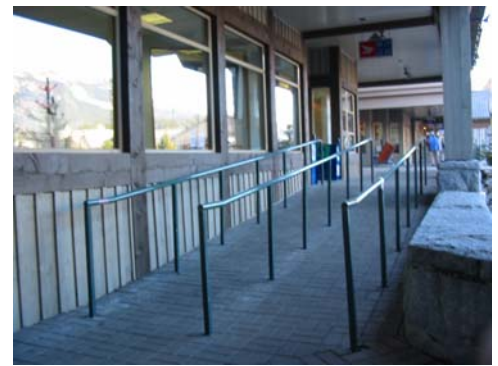
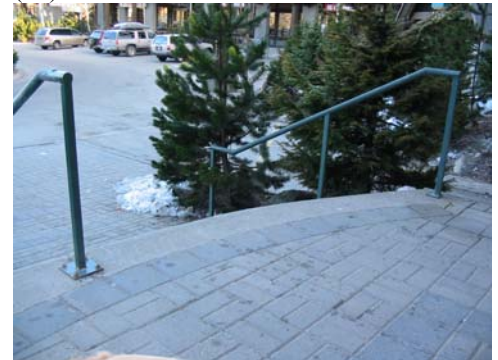
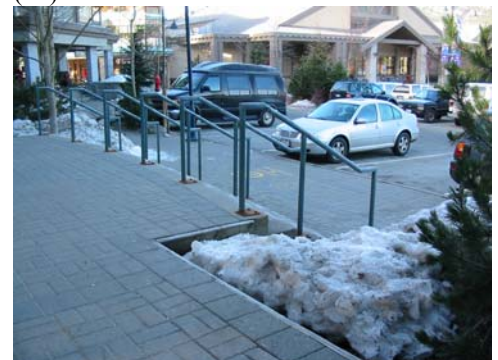
Seven sets of stairs provide access to this area from the parking lot. Each of these sets of stairs has significant problems that could result in falling hazards. From the Marketplace Lodge side, the first set of stairs is a semi-circle design that provides three handrails. The outside handrails are blocked by landscaping that has been allowed to grow over the rails, rendering them useless (13). These stairs have no tactile warning at the top of the stairs or high contrast nosings on each step, as required by the current BCBC.

The last two sets of stairs along this route have no tactile warning at the top of the stairs or high contrast nosings on each step, as required by the current BCBC. The last set also shows a serious settling of the pavers at the base causing the ground to slope away from the stairs, rather than provide a flat landing.

Ramp access at this end of the retail area (near Main St) is too steep for access by most wheelchair users.

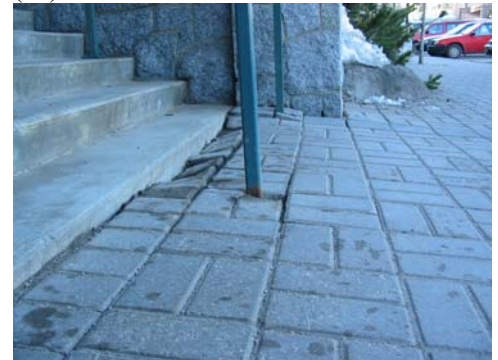
(14)

The next set of stairs has an extensive erosion problem resulting in broken pavers and uneven ground at the base of the steps. In addition, the ground settling has caused the sidewalk to slope away from the base of the steps creating a falling hazard for all users (14).

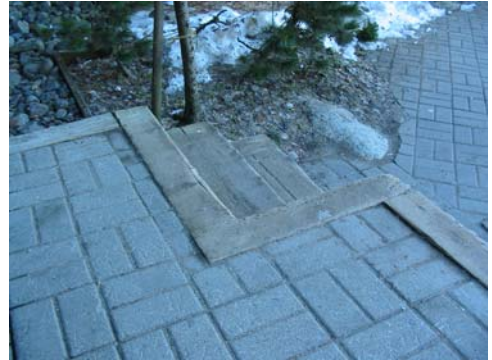
(16)

In addition to the six sets of concrete stairs, there are two wooden stairs adjacent to the loading zone. These steps have worn wooden nosings, no handrails and unprotected drop offs (16). Neither of these sets of stairs meets current BCBC requirements and both represent a falling hazard to most people with disabilities.

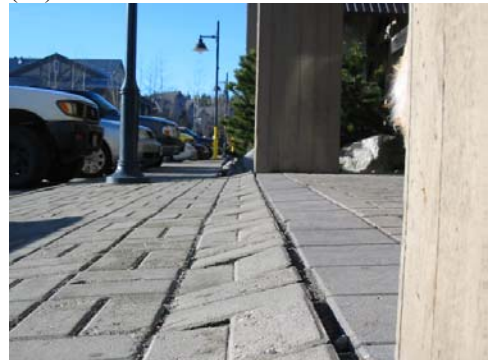
(19)

At the north end of the Marketplace, the Professional Building is a raised area requiring users to climb four steps or use an elevator to access the businesses here. Settlings of the brick pavers has created a difficult pathway for people with mobility impairments and people using walking aids. The route to the elevator is narrow and the ground surface uneven (19).

- Develop an accessible route connecting the Professional Building to the Northlands Blvd sidewalk and/or the crossing to the south side of the Northlands Blvd entrance.
- Repair/replace the sloping pavers along the approaches to the building/elevator.
- Elevator Recommendations
 - Create a light coloured floor in the elevator cab
 - Install handrails with a graspable surface in the elevator cab
 - Mark the floor sills at each level in a high contrast colour – preferably signal yellow.
 - Relocate the 'star' symbol to indicate true ground level

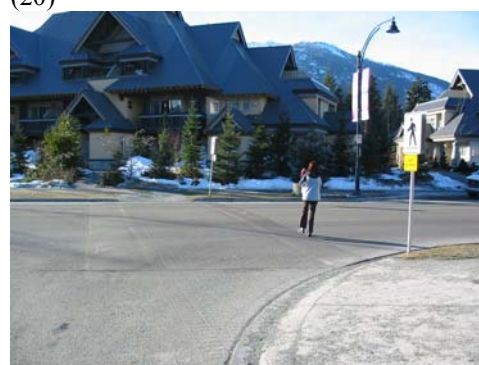
(21)

The second is located at the south end of Main Street and offers rolled curbs on both side (21). Again, the painted lines marking this crosswalk have faded and are difficult to see.

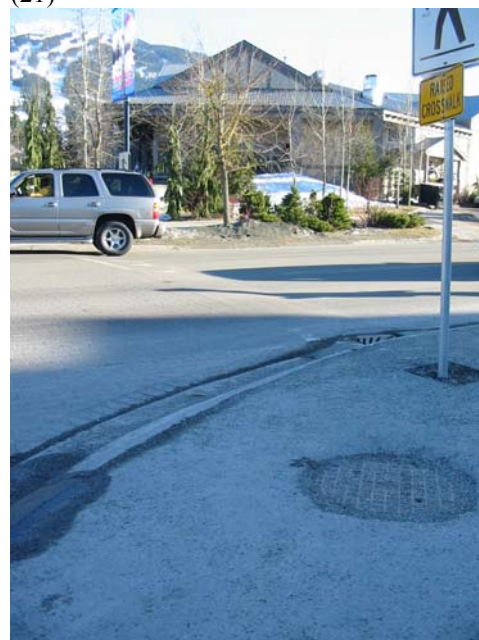
(22)

The third is located at the south end of Main Street and offers rolled curbs on the east side and unmarked curb ramps on the west side (22). This affords some access to power wheelchair users and some manual wheelchair users. Here too, the painted lines marking this crosswalk have faded and are difficult to see.

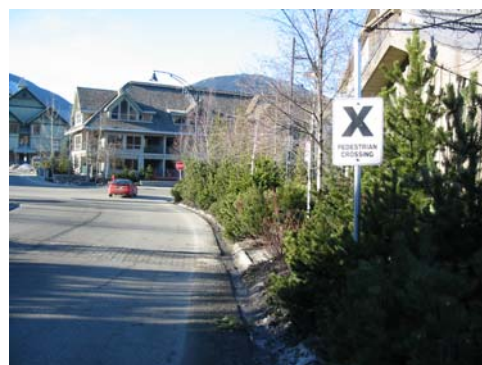
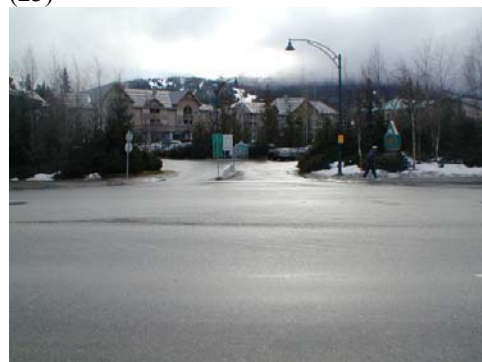
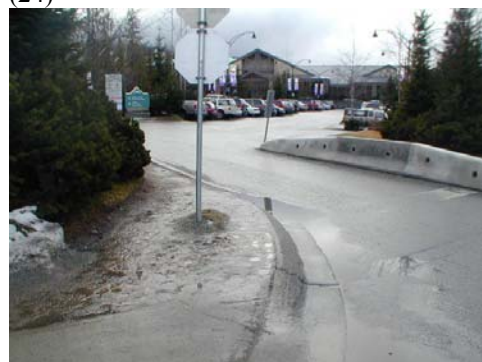
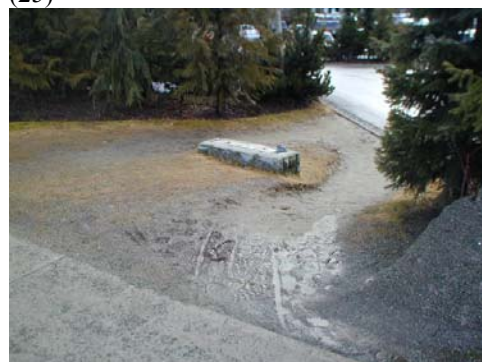
The only sidewalk route to the Marketplace other than the Village Stroll is from the Northlands entrance. The south side of the driveway provides a continuous sidewalk linking to the Marketplace pathways. The north side entrance does not. There is a marked crossing connecting the Professional Building to the south sidewalk but it does not have an appropriate ramp or curb ramp (23). There is no direct access to the Professional Building for wheelchair users or others requiring ramped access.

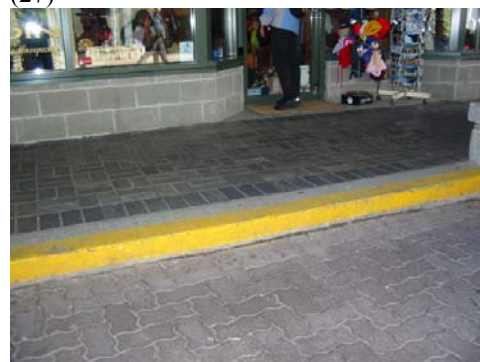
(28)

Throughout the entire length of the Village Stroll there is only one step marked in a high contrast colour (28). Highlighting steps in this way makes them visible to many people with visual impairments as well as emphasizing the level change to other users. This type of preventative measure is fundamental to creating a safe environment for seniors and people with visual impairments. All steps connecting the retail and restaurant areas with the Village Stroll should have high contrast, non slip nosings.

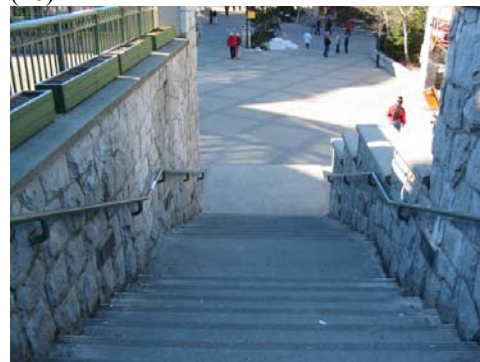
(29)

The grand staircase connecting the Village Stroll to Blackcomb Way has appropriate handrails but not high contrast nosings. As a result the steps are difficult to delineate from each other making descending unnecessarily difficult for people with visual impairments and many other users (29). The lighting on these steps is uneven and casts broad, irregular shadows. As a result they are difficult for all users at night, but particularly for people with vision impairments. Similarly, the staircases just to the south at the Village Inn and the Keg Restaurant do not provide high contrast nosings as required (30). Neither of these staircases offers a continuous handrail. This makes use of these stairs both difficult and hazardous for people with mobility impairments and people with visual impairments. There is no wheelchair access to the Village Stroll from these areas.

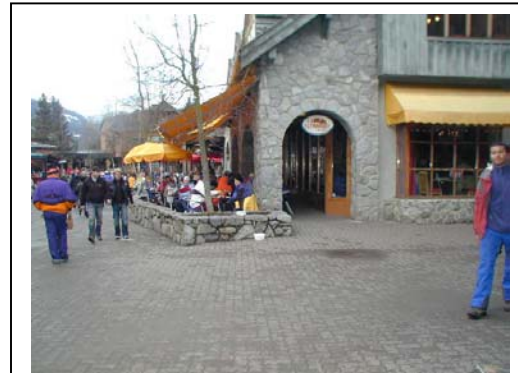
(31)

The only wheelchair access to the restaurants and shops located in the 'The Fitzsimmons' is located on the most southern point of the building (31). The pedestrian route is narrowed by the swing path of doors, restaurant seating and display space. As a result, this area is largely inaccessible for practical purposes.

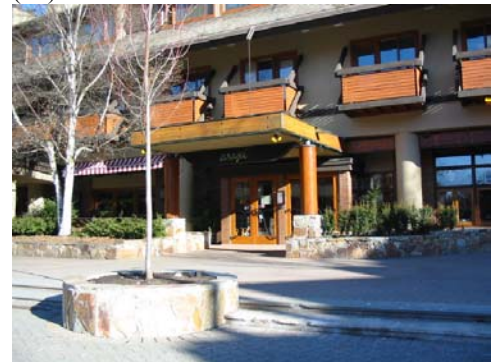
(32)

On the other side of the Village Square, in front of the Blackcomb Lodge, there are two steps that do not have high contrast nosings (32). As a result, they would be difficult to see by people with visual impairments especially because of the low rise design and especially at night. Next to the Lodge there are long lengths of unprotected drop offs in front of high traffic areas including the liquor store, the grocery store and the drug store (33). These edges represent an extreme hazard to all users – particularly people using walking aids, wheelchair users and people with visual impairments. People using this area after dark are particularly at risk.

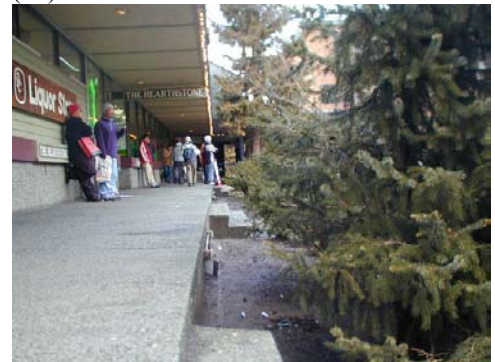
(33)

Further, the stairs in this area do not provide high contrast nosings or appropriate handrails as required by BCBC. The lack of high contrast nosings makes it very difficult to delineate each individual step. Ineffective handrails increase the risk beyond acceptable levels.

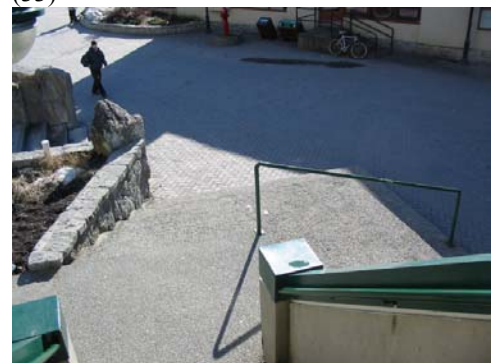
(34)

Handrails on the stairs at the drug store entrance do not provide a graspable surface. There are no handrails at all on the steep steps near the liquor store. People with visual impairments searching for handrails here are at risk of falling into the unprotected drop offs on either side of the stairs. Other stairs in this area offer an obscure handrail arrangement cutting diagonally across the steps but offering no assistance at the sides of the stairs where most users would expect handrails (34). None of the handrails in this area meet the requirements of the current BCBC.

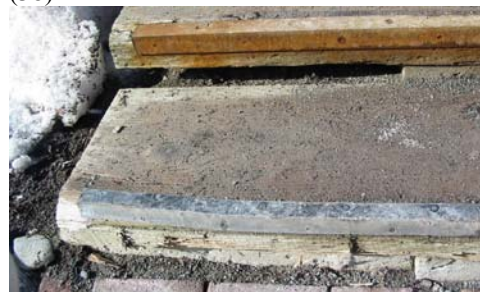
(39)

The Day Lodge and the assorted restaurants and shops are only accessible from the north end by people unable to use stairs. Some of the stairs here are deteriorating and could become tripping hazards for all users (39).

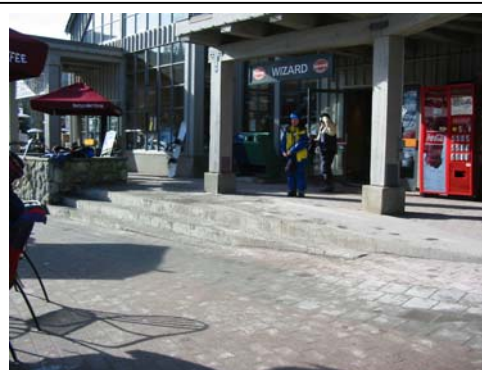
(40)

Along the Upper Village Stroll there are at least three sets of stairs built into the grade. The result is a series of edges created where the stairs first emerge from the sloping path (40). These steps are concrete and blend into the surrounding surfaces rendering them almost invisible to all pedestrians – and even more so for people with visual impairments. It is essential that these steps are marked in a high contrast colour, particularly at the beginning of the slope where the step edges become tripping hazards.

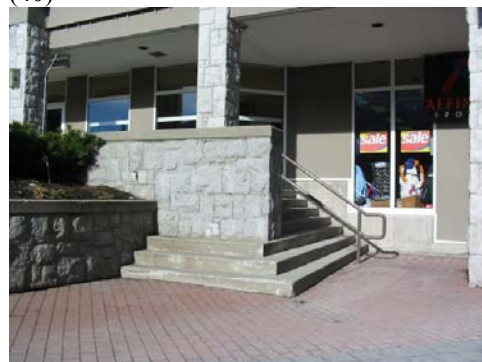
(41)

The stairs leading up to the retail area of Le Chamois are unmarked and have a complete section leading directly into a stone wall (41). The main section of steps has only a centre handrail with insufficient colour contrast to meet requirements. On the top landing of the steps, there is a stone support pillar blocking almost 1/3rd of the stairs (42). This would be very difficult for most people with visual impairments to see in order to avoid a collision.

This stair design is full of misinformation for people who have low vision or who are blind and they should never have been allowed to be built.

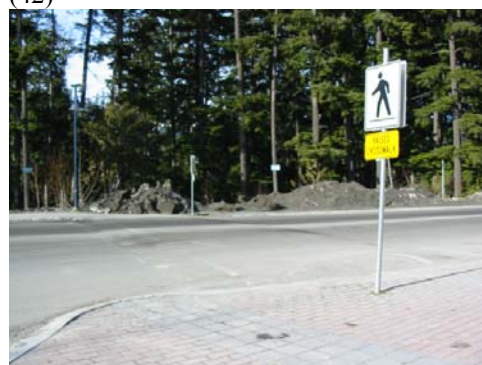
(43)

The crosswalk linking the Upper Village with Day Parking is a raised style which could have been very useful for wheelchair users and other people with mobility impairments. However, instead of extending the raised portion to meet the rolled curbs on either side, they stopped short, leaving a gap between surfaces (43). This creates a difficult 'down, then up' movement on the wheelchair and therefore increases the tripping/falling hazard at this intersection as well as making it unnecessarily difficult for wheelchair users.

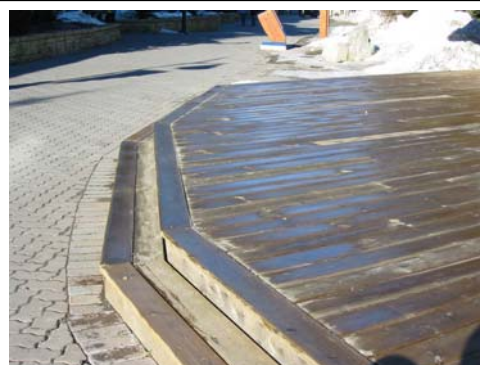
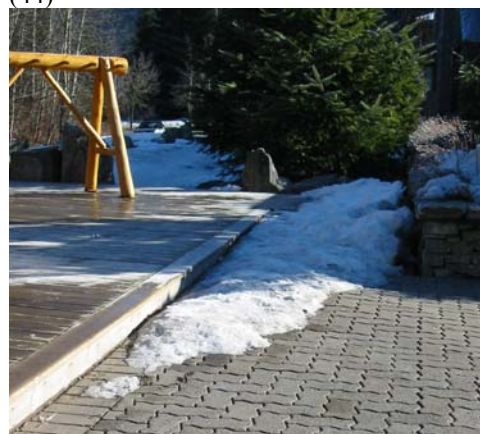
This is a portable building that has had a deck added to it. The deck has a wood surface with either 1 or 2 steps up depending on which side is being approached. These steps would be difficult to see by most people with visual impairments because they have no high contrast nosings or tactile warnings as required by the BCBC (44). Further, the wood surface becomes extremely slippery in wet, frosty or snow conditions resulting in a falling hazard on many days.

Interior and exterior bulletin boards are located unnecessarily high for use by wheelchair users and others.

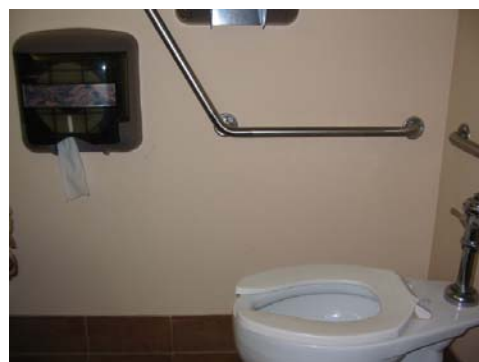
(46)

- There is no back rest or toilet seat lid as required by current BCBC (46).
- The flush handle is located on the wrong side and creates a fall hazard for most wheelchair users – BCBC (46).

- Relocate the toilet paper dispenser to an operating height 50 – 100mm below the mid-point of the side grab bar.
- Install a toilet seat lid or backrest on all toilets.
- Upgrade the automatic door closers to a low resistance, delayed action closer.
- Replace the paper towel dispenser with a lever operated design.
- Install a coat hook in these washrooms to the standard height of 1200mm from the finished floor and locate on an open wall inside the room.
- Replace existing toilet paper dispensers with standard open roll holders.
- Replace paper towel dispensers requiring good hand function with a lever operated design.
- Relocate paper towel dispensers to a maximum operating height of 1200mm from the finished floor.
- Improve directional signage used to locate washrooms from main pathways.
- Improve room signage utilizing the international symbols, shapes and tactile information.

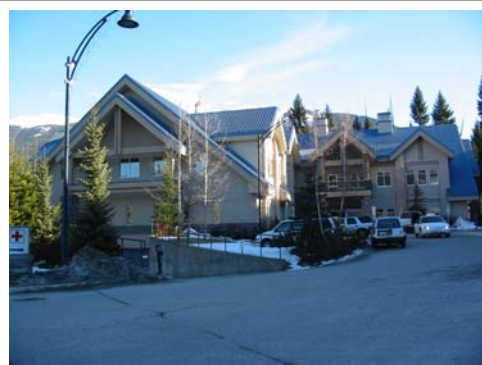
(50)

There is no connecting sidewalk the links the front entrance to Lorimer Road (50). For people not driving, there is no approach that does not require users to travel in the roadway.

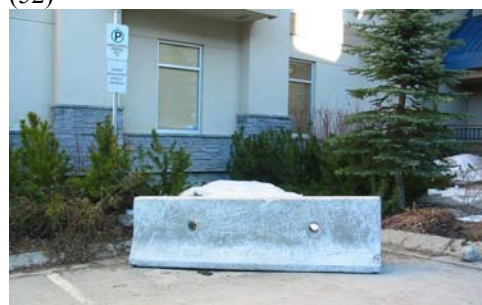
(53)

There is one designated parking space for people with disabilities. It will accommodate standard vehicles but not lift equipped vans. At the time of the survey, a large concrete abutment was blocking all use of this space (53).

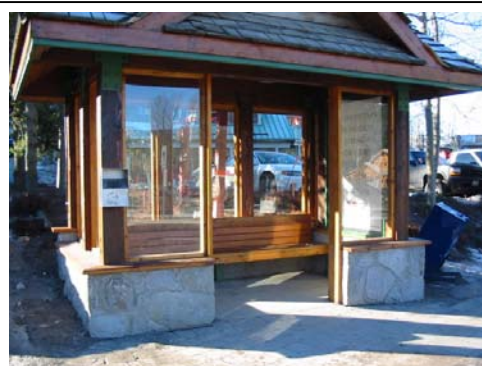
(54)

There are two problems found with the bus shelters. Most have a full length bench inside which blocks wheelchair users from entering the shelter (54). The second barrier was found at all shelters except two in Creekside. There are exposed concrete lips at the entrance and broken uneven ground in front of the shelters (55). It appears that this is the result of erosion. This renders the shelters inaccessible for wheelchair users and many people using walking aids. The large shelter on Village Gate Blvd is not accessible to wheelchair users and most people using walking aids because of the two high steps at the entrance.

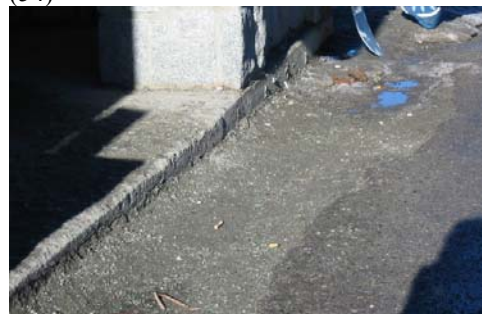
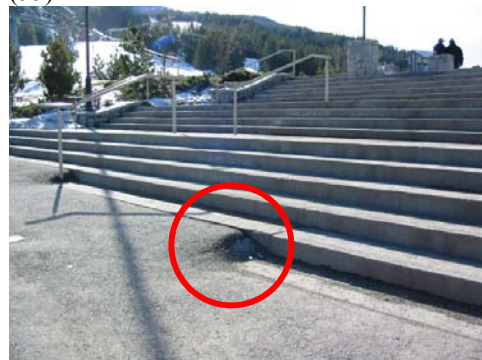
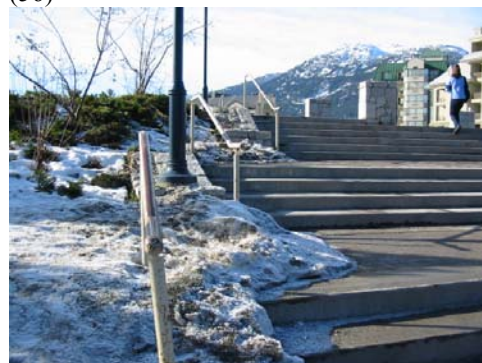
There is ramped access to this exchange from the adjoining sidewalks. Access from Village Stroll is via a grand staircase leading from Mountain Square. These stairs are a poor design for most users, particularly people wearing ski boots, people with mobility impairments and people with visual impairments. The handrails here do not meet BCBC requirements because there is no continuous handrail (57). In practical terms the three flights of stairs have randomly placed handrails. Some begin after the first flight, stop and then restart again on the bottom flight (56). The stairs are wider at the bottom than at the top. Snow has been allowed to encroach on the lower levels creating a significant tripping hazard. There are stone columns at the top of the stairs with no apparent use. Because they are the same colour as the sidewalk and stairs they would be difficult for people with visual impairments to identify. The stairs have neither high contrast nor tactile markings.

The stairs on the Mountain Square side has a significant unprotected drop off along the sidewalk edge. Users following the direction given by the handrail would be guided directly into this drop off. On the bus loop side the asphalt at the base of the steps creates a tripping hazard (56). To add to the frustration of these stairs is the reality that for the most part they are unnecessary. There are stairs on both sides meaning that users must climb up one side, only to go down the other.

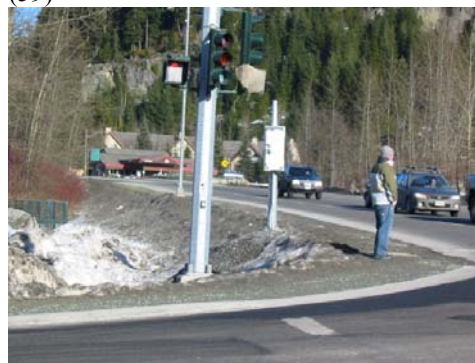
(60)

This intersection connects commercial and residential areas with the Creekside Gondola. The area was under construction at the time of the survey however this intersection appears to have been built without any consideration for people with disabilities. There are visual crossing signals that are activated by large push button controls mounted on lamp posts – however they are well off of the pathway on a downhill slope (60). There are no audible crossing signals.

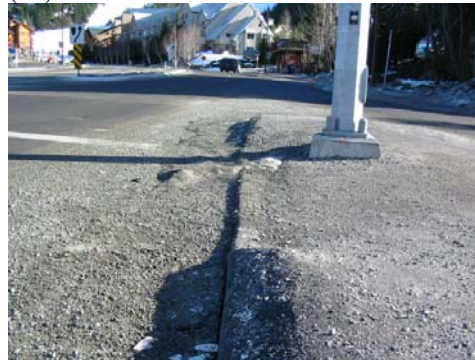
(61)

The crossings on both sides link to an asphalt island via a cut out in the asphalt. The lip at the bottom of this ramp makes this ramp difficult for wheelchair users (61). This 'curb ramp' would be completely invisible to people with visual impairments. Further, the islands do not offer a connecting route for people with mobility impairments to exit the island without sending them out into opposing traffic. Once in the roadway, there is no link to the sidewalks and pathways on the west side. As it stands, this is not an accessible route.

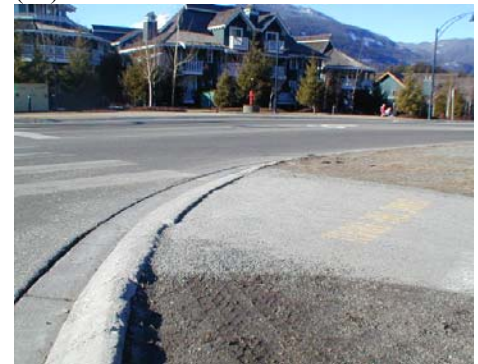
(64)

No proper curb ramps have been installed and as a result there are no tactile strips available to assist people with visual impairments. Unlike many other sidewalk routes, some of the rolled curbs on the corners have been flattened enough to provide a smoother transition to the roadway. Still, these are not suitable transitions (64). There are marked pedestrian crossings on all sides of this intersection.

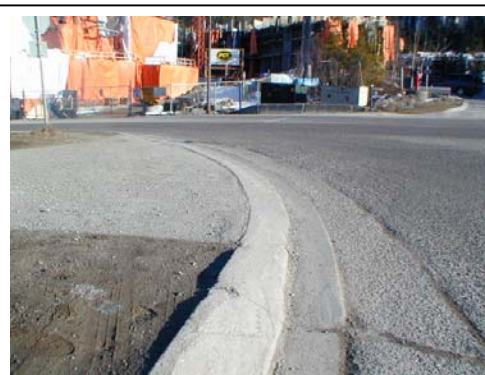
No proper curb ramps have been installed and as a result there are no tactile strips available to assist people with visual impairments (66) and use by wheelchair users and other would be unnecessarily difficult. There are no marked pedestrian crossings at this intersection.

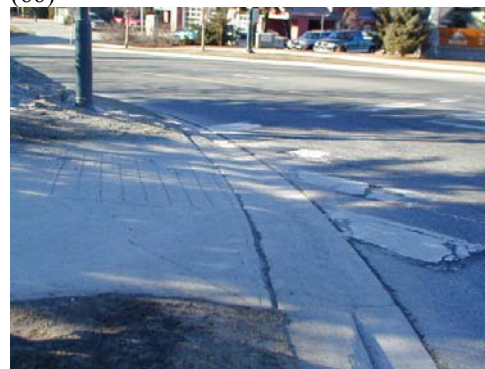
(67)

No proper curb ramps have been installed and as a result there are no tactile strips available to assist people with visual impairments. Unlike many other sidewalk routes, the rolled curbs on each the west side have been flattened to provide a smoother transition. There are marked pedestrian crossings – although they require new paint (67). There is no access for people with mobility impairments to the day parking areas from this intersection.

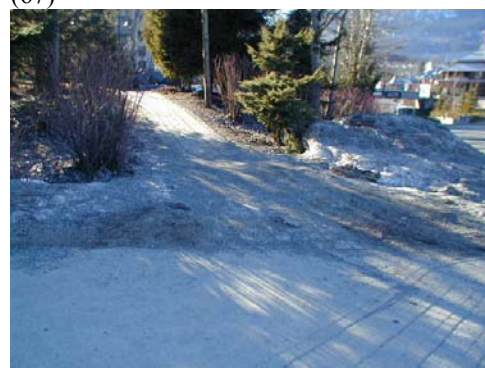
(68)

Also located here is a ramped approach to the Village Stroll (68). Although quite steep at the onset, for those able to use it (with help or independently) it could dramatically reduce the distance to travel than other routes to the Stroll. Unfortunately the route is blocked for wheelchair users by a curb (69). This curb is also a significant tripping hazard to other users – particularly people with mobility impairments.

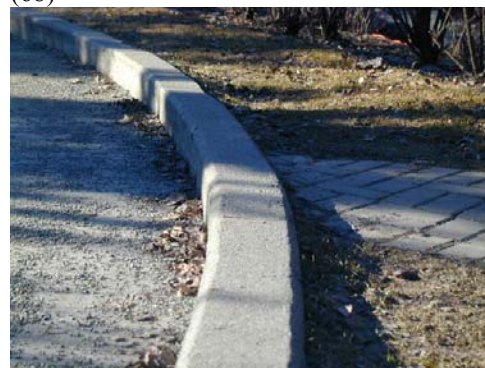
(69)

No proper curb ramps have been installed and as a result there are no tactile strips available to assist people with visual impairments. Unlike many other sidewalk routes, the rolled curbs on each the four corners have been flattened enough to provide a smoother transition to the roadway. There are marked pedestrian crossings.
